Susceptibility of Chickpea Varieties to Impact Damage

PRAIRIE AGRICULTURAL MACHINERY INSTITUTE

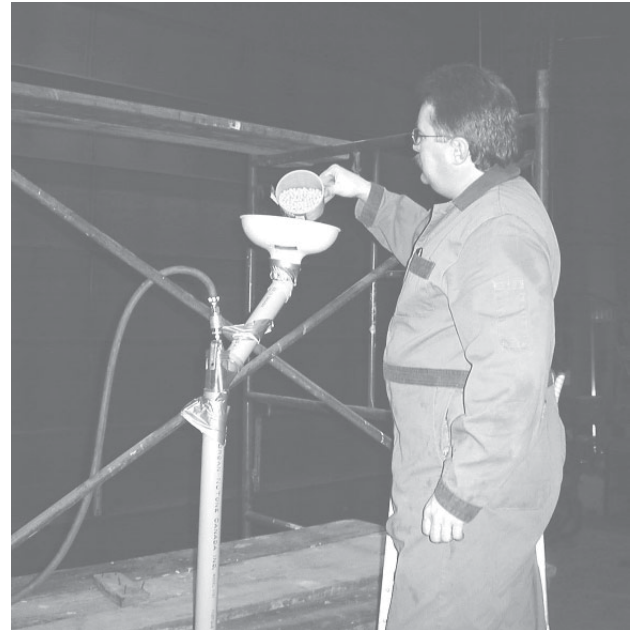
Figure 1. Impact Test Stand.

A number of impact protocols were developed to differentiate impact damage among chickpea varieties. Gravity impact, using gravity to accelerate seeds at heights as high as 6 m (20 ft), was not successful in providing enough impact velocity to generate physical damage differences among the varieties. As a result, impact velocity was increased by using compressed air to increase impact damage. The test set-up successfully used for the experiment consisted of a vertical 2.4 m (8 ft), 51 mm (2 in) inside diameter PVC pipe (Figure 1). At the top of the pipe a Y was installed with a 45 cm (18 in) PVC pipe angled at 45° to the vertical. A funnel was attached to the top of the pipe to direct seeds into the system. A compressed air discharge nozzle was attached to the top of the vertical pipe to provide a high velocity air stream within the pipe. Air velocity at the discharge end of the vertical pipe was measured at 29 m/sec (95 ft/sec). Just below the bottom (discharge end) of the pipe, a steel impact plate was mounted at 50° from horizontal. The steel plate was mounted inside a plastic rectangular tub with most of the surface covered to prevent escape of the impacted seed. Seeds were poured into the funnel, and flowed into the vertical pipe, where they were accelerated with the compressed air blast until they impacted the steel plate. The 500 g (1.1 lb) test samples were evenly poured into the funnel over a 20 to 25 second interval. To increase the

damage, each sample was run through the test twice. Following the second impact run, seeds were collected from the plastic tub and subjected to cracking and germination analysis. Cracks were removed by hand screens and then samples were hand-cleaned to remove all cracked or broken seeds. The remaining clean sample was sent to an accredited seed lab for germination testing.

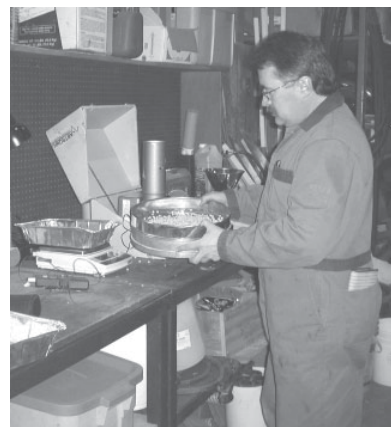
Sorting seeds after impact test.

Chickpea damage was evaluated using two different methods. The first method was by visual inspection of physical seed damage including splits, cracks, or any seed coat penetration. Physical seed damage was quantified by removing damaged seeds from the sample and expressing this weight as a percent of the original sample weight. The second assessment method was to quantify hidden damage to the seed. Hidden damage was determined by sending the undamaged seeds to an accredited seed lab for germination tests. Total damage was calculated as the sum of percent physical damage plus the percent reduction in germination.
